FIXED IMPRESSIONS WORK MAT

Most Common Problems with Fixed Impressions

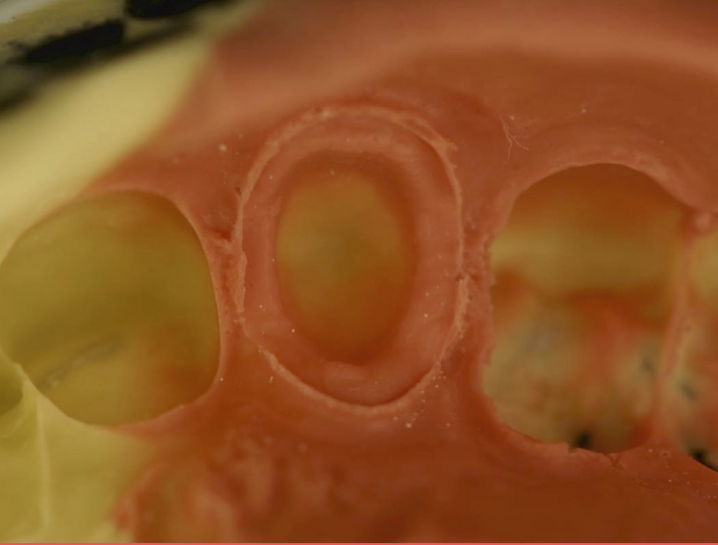
AN EXCELLENT IMPRESSION

- No tearing of the wash from the putty around the preparation
- Detailed and complete margins
- No tooth contact with tray; impression centered on tray
- Tray adhesive applied properly
- Properly mixed material; no streaking
- Strong bond between tray and wash materials; no signs of debonding or ledges
- No voids; full, smooth wash material coverage

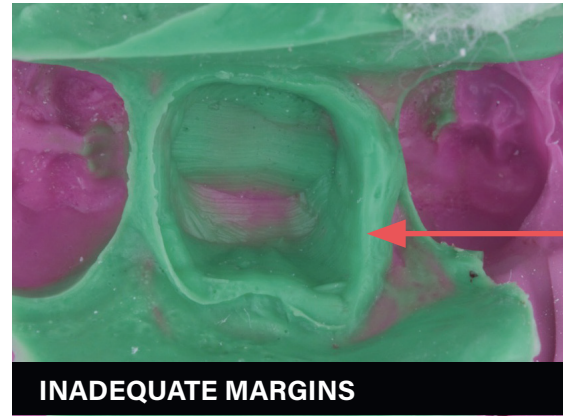
INADEQUATE MARGINS

Probable Causes:

- Incomplete sulcular expansion around the preparation
- Improper moisture control around the preparation
- Exceeding the material's working time
- Tray movement after seating

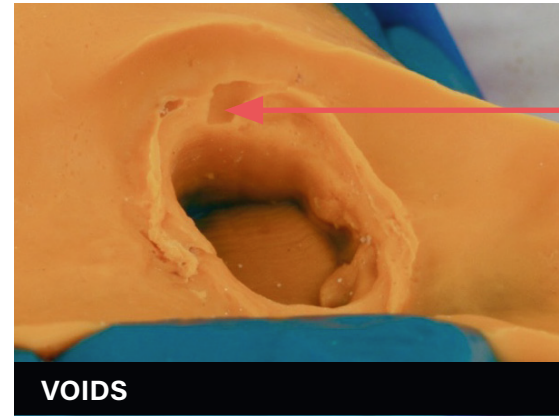
VOIDS

Probable Causes:

- Improper syringe technique
- Sulcular fluid/bloods/contaminants
- Incomplete sulcular expansion around the preparation
- Tray incorrectly seated
- Insufficient preparation covered by the impression material

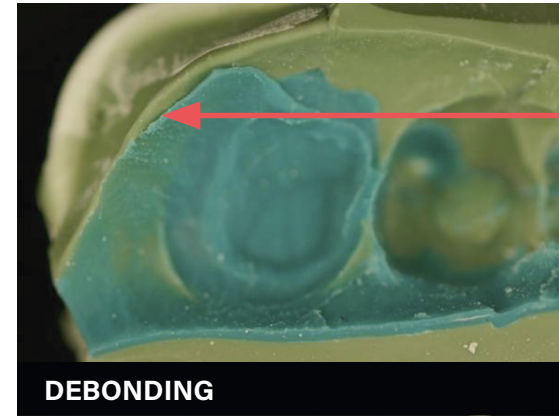
DEBONDING

Probable Causes:

- Exceeding the material's working time
- Contamination of tray material
- Impression material stored at a temperature above manufacturer's recommendation

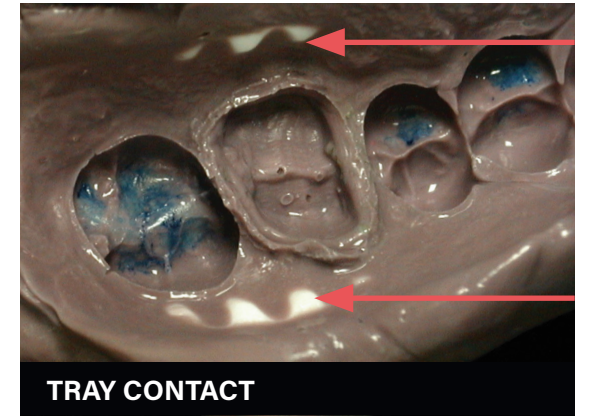
TRAY CONTACT

Probable Causes:

- Incorrect tray size used
- Tray not oriented correctly
- Insufficient impression material used

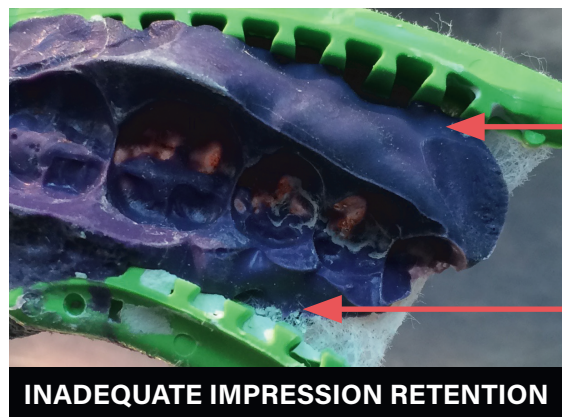
INADEQUATE IMPRESSION RETENTION

Probable Causes:

- Insufficient impression material used
- No tray adhesive used
- Inadequate tray adhesive drying time
- Outdated impression material used

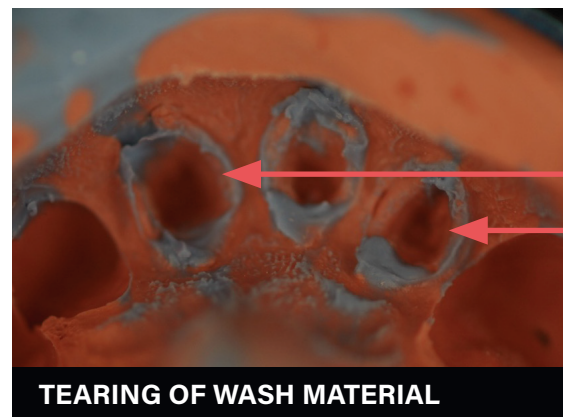
TEARING OF WASH MATERIAL

Probable Causes:

- Insufficient retraction around the preparation
- Impression removed before material has set
- Improper moisture control around the preparation
- Outdated impression material us

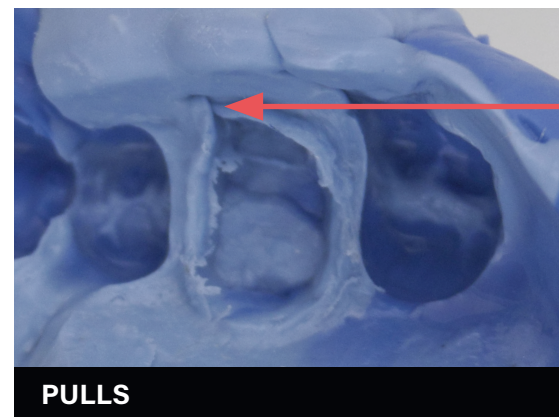
PULLS

Probable Causes:

- Exceeding the material's working time
- Tray movement after seating the impression
- Insufficient impression material used
- Rapid seating of the impression tray

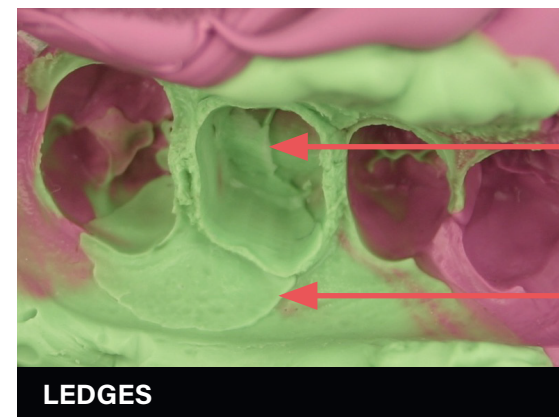
LEDGES

Probable Causes:

- Preparation of most posterior tooth is contraindicated with dual-arch trays
- Buccal, lingual and posterior tray contact
- Lack of occlusal clearance
- Extreme mesh exposure

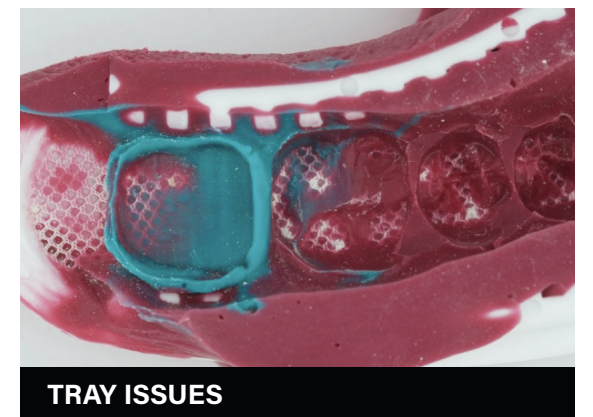
TRAY ISSUES

Probable Causes:

- Incomplete sulcular expansion around the preparation
- Improper moisture control around the preparation
- Exceeding the material's working time
- Tray movement after seating
